**Watching Brief on building works in
Gardiner's Wing,
Farnham Castle**

May 2006

David Graham and Michael Clements

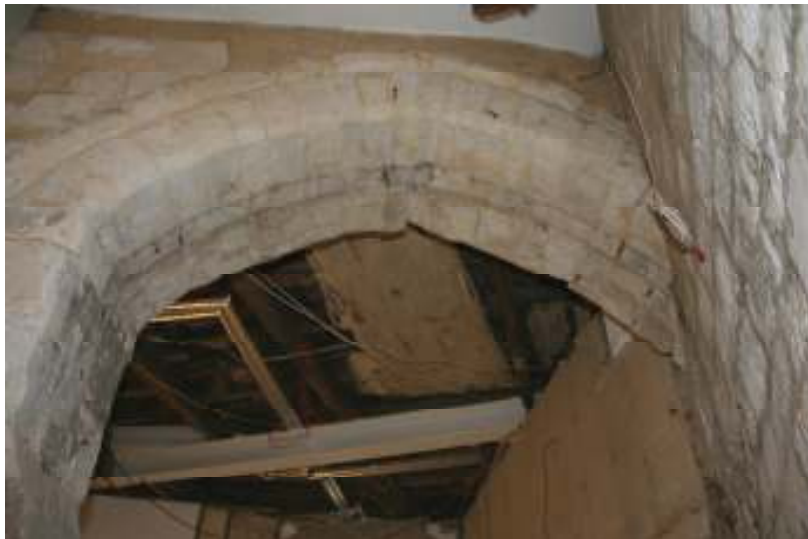
Archway exposed during works

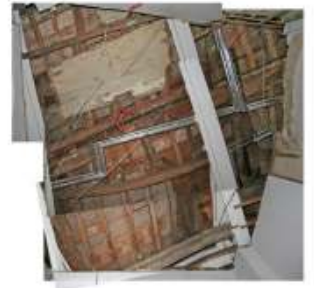
FC24 Room D ceiling

Photographs 19–23 and 25–29 show the floor joists of the Chapel that exists above rooms C and D. The floor of the Chapel is on several levels and this is reflected in the underlying woodwork which consists of a distinctly ad hoc arrangement of joists and small timbers.

21. View of ceiling joists south east section Room D
22. View of ceiling joists south west section room D
23. View of ceiling joists centre of Room D
24. Photo montage of ceiling of Room D

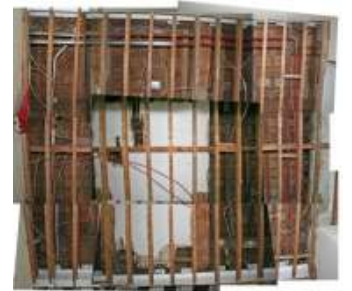
FC44 Rooms A & B ceiling

Photographs 35–44 show the ceiling/floor joists of rooms A and B the lower element of which is modern though the upper layer appears to be somewhat older – again possibly 18th century.

42. View of ceiling joists south centre section of Room AB
43. View of ceiling joists south west section of Room AB
44. Photo montage of ceiling of Room AB
