Excavations at the Royal Manor House of Guildford Park, 1972–75

ALAN CROCKER

2014

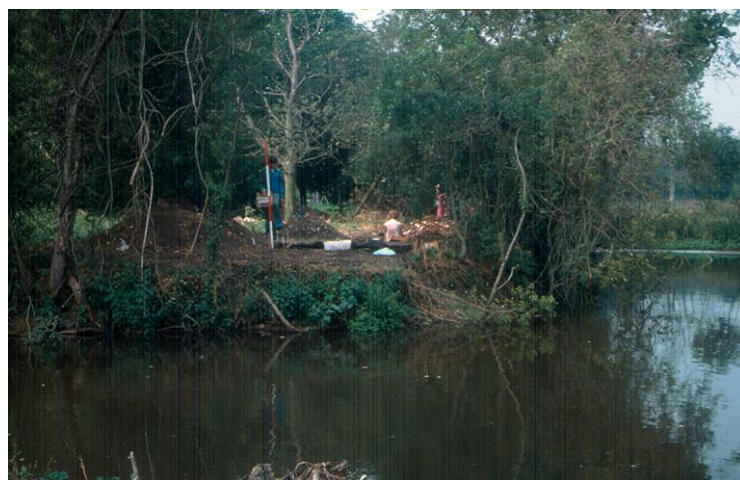
Fig 2 Guildford Park Manor. Photograph, taken in July 1975, of the north-east corner of the island looking north-west across the moat.

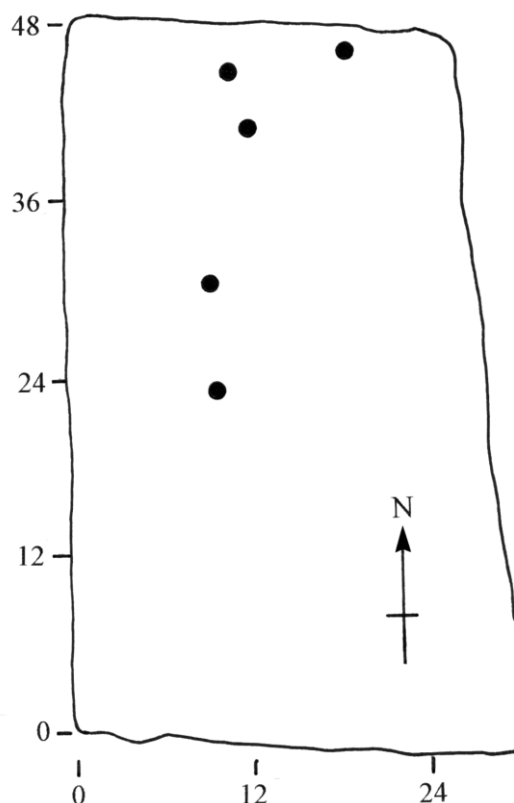
Fig 4 Guildford Park Manor. Locations of strong water-divining reactions observed on the moated island. The scales are in metres based on the origin at the south-west corner of the island.

On 24 August 1972, Brian Van Zyl, an experienced water diviner, surveyed the moated site using two bent brass rods, one held in each hand and both projecting horizontally in front of him by about 0.4m. He had reactions, the rods crossing each other, at 24 places on the northern half of the island. The five strongest reactions were at the locations plotted in figure 4. These have the following co-ordinates in metres east and north of the site origin (fig 1): [9.7, 23.0], [9.0, 30.3], [12.0, 41.0], [10.5, 44.6], [18.5, 46.0]. Others present (including the author) also used the rods briefly and had strong reactions in some of the same places but none elsewhere.

It may be of interest to note here that no evidence was found of water or particularly wet deposits at the sites where high responses were recorded during the water-divining survey of the site.

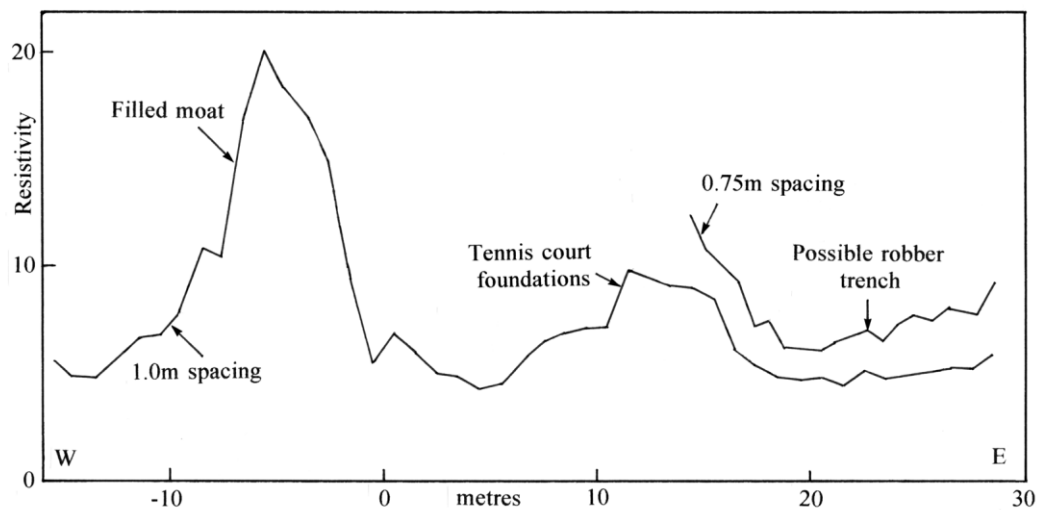
Fig 5 Guildford Park Manor. Plot of an east-west resistivity traverse across the island and the filled western side of the moat about 30m north of the site origin. The survey was carried out on 13 May 1972 using the twin electrode configuration with probe spacings of 1.0m and, for part of the traverse, 0.75m. Note the very high readings for the filled moat between -8m and -2m, high readings for foundations used to level the brick tennis court between 11m and 16m and the possible robber trench at 23m.

An east-west earth resistance traverse, about 30m north of the site origin and 45m long, was made across the island and the west side of the filled moat on 13 May 1972, prior to the commencement of the excavations. This was an early application of the twin-electrode probe geometry in which two probes remain at fixed locations in a remote corner of the site while the remaining two are moved across the region being investigated (Clark 1990, 44–6). A probe spacing of 1m was used but the eastern part of the traverse was repeated at 0.75m spacing. Unfortunately, it was difficult to obtain reliable readings for the part of the island covered by the brick foundations of the tennis court. The results are shown in figure 5. The readings for the moat section (-8m to -2m) were higher than those for the island by a factor of about three. This was unexpected, as it was thought that the fill of the moat would be damp and therefore have low resistivity. The high values implied, on the contrary, that the fill was dry, which gave rise to the suggestion that this part of the moat was filled with loose building

The earth resistance survey undertaken prior to the excavation (fig 5) had suggested that the dry western side of the moat was probably filled with building rubble from the manor house. It was therefore decided to excavate an east-west trench 1m wide and 9m long across the moat to test this hypothesis and to determine the depth of the moat and the nature of its retaining walls. The most convenient location for this trench, allocated the letter A, proved to be between 31.7 and 32.7m north of the origin at the south-west corner of the island. This meant that its northern edge was aligned with the north edge of a possible later excavation of AK. Initially the trench was taken down, mainly through loose mortar, flints and broken tiles until water was reached at a depth of about 1.80m from the surface (fig 10). This was the current water level in the moat at the northern end of the island. The top of the outer

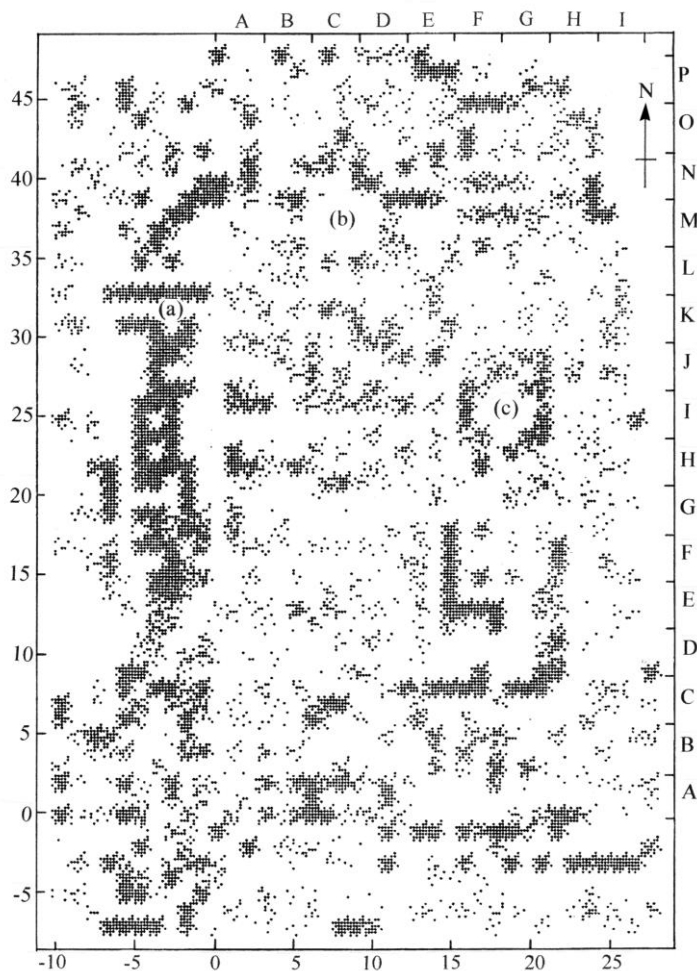
Fig 6 Guildford Park Manor. Dot-density plot of the results of an earth resistance survey of the island and the filled western and southern parts of the moat carried out on 23, 30 July and 7, 14 August 1972. The double-dipole probe geometry was used with a probe spacing of 1m. The scales at the left and the bottom are in metres and refer to the site origin at the south-west corner of the island. The code letters at the right and the top define the squares into which the island was divided during the excavations. Note the high readings for the filled moat at the west. No readings could be taken for the areas marked (a), (b) and (c), corresponding to the trench across the moat, the garden pond and the summer house respectively.

A comprehensive earth resistance survey of the whole island site and the filled south and west sides of the moat was carried out, using the double dipole configuration, during July and August 1972. The probe spacing adopted was 1m and about 2500 readings were taken. These covered a range of values varying by a factor of over ten, the highest being associated with the filled western side of the moat. However, comparatively high values were also found for parts of the island. A dot-density plot of the results is shown in figure 6.

It was not the intention of the excavation to investigate the manor house in detail but some information was obtained and this section reports the results. As shown in figure 9 and discussed above, the excavation of the inner retaining wall of the moat revealed about 8.5m of substantial foundations that are considered to represent the northern part of the west wall of the house. The earth resistance surveys give an indication of where some of the other walls may have been located. That of the whole island plotted in figure 6 has high values,

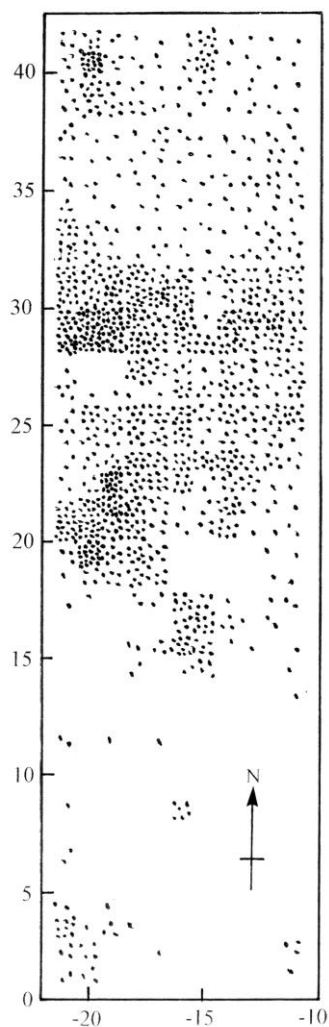
Fig 7 Guildford Park Manor. Dot-density plot of the results of an earth resistance survey of the area between the western part of the moat and the farmhouse carried out on 26 July 1975. The double-dipole probe geometry was used with a probe spacing of 1m. The plot is immediately west of that shown in figure 6 and the scales, in metres, refer to the site origin at the south-west corner of the island.

On 27 July 1975 a rectangular area of lawn, measuring 41m north–south and 11m east–west and lying between the west side of the moat and the farmhouse, was surveyed using earth resistance with both the traditional Wenner array and the double-dipole probe configurations at 1m spacing (Clark 1990, 37–44). A plot of the double dipole results, immediately west of that in figure 6, is shown in figure 7. Low readings were recorded for most of the northern and particularly the southern sections of this area, indicating very damp soil and no hidden building foundations or rubble. However, very high readings were obtained, using both configurations, for an irregular central region lying from 19 to 33m north and 12 to 21m west of the site origin. It seems likely that this corresponds to the site of a former building associated with either the manor house or the later farm.

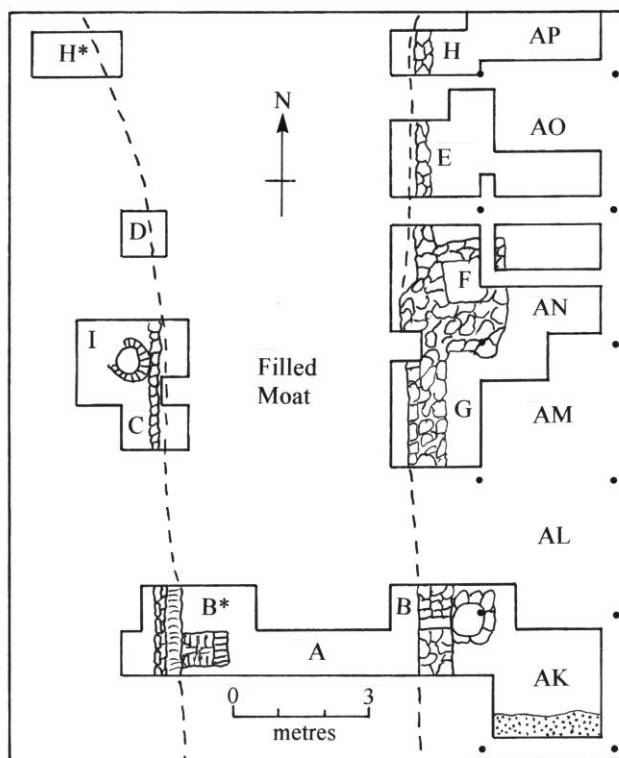
Fig 9 Guildford Park Manor. Outline plan of the excavations associated with the moat and the three garderobe pits at the west of the island. The broken lines show, approximately, the edges of the filled moat as indicated by surface features. The array of dots at the right defines the locations of AK to AP into which this part of the island was divided. The shaded area in AK represents a robber trench. Features discovered in the other squares are indicated in figure 20.

Further small trenches were excavated on each side of the moat north of A in order to provide more information on the alignment and structure of the retaining walls. In the plan of figure 9, these are labelled C, I, D and H* on the west or farmhouse side and G, F, E and H on the east or island side. Considering the west side first, about 9m² was excavated. In C, which was 5m north of A, the top of the revetment wall was found at a depth of 0.2m. However, it was not present at this depth in D or at a depth of 0.5m in H*, which were 9.3 and 13.3m

The four trenches, G, F, E and H, on the east side of the moat, covered 14.6m² and all revealed features of the retaining wall of the moat. This, as shown on the plan of figure 9, continues its alignment in A and B described above. In F, about 8m north of A, it narrowed from about 0.8 to 0.5m and then, after a further 1m, it narrowed again to 0.3m. Assuming that the thicker foundations supported a wall of the manor house, this suggested that gardens and outbuildings, rather than a substantial building, occupied the northern end of the island. The thicker wall had been robbed to an average depth of about 1m but the top of the narrow wall was only about 0.2m below the surface. In F, what appeared to be an approximately square garderobe pit was discovered and excavated. Again its structure will be described in the next section.

During the excavations of the moat and its retaining walls described above, three rubbish/latrine garderobe pits were discovered. These are shown on the plan of figure 9. Garderobe 1 was the structure built of chalk blocks discovered at the eastern end of A and revealed fully in B (fig 12). It was of circular cross-section, 0.75m in diameter, 1.7m deep, and adjoined the island side of the moat wall. Again, water had to be pumped continuously in order to investigate it fully. The base was constructed of thin bricks and wood, part of which had decayed, showing a chalk floor beneath. The wood was part of a plank that also formed the base of a drain running through the footings of the moat wall. This drain was 30cm high and tapered from about 10cm wide at the inner or garderobe end to 24cm at the outer or moat

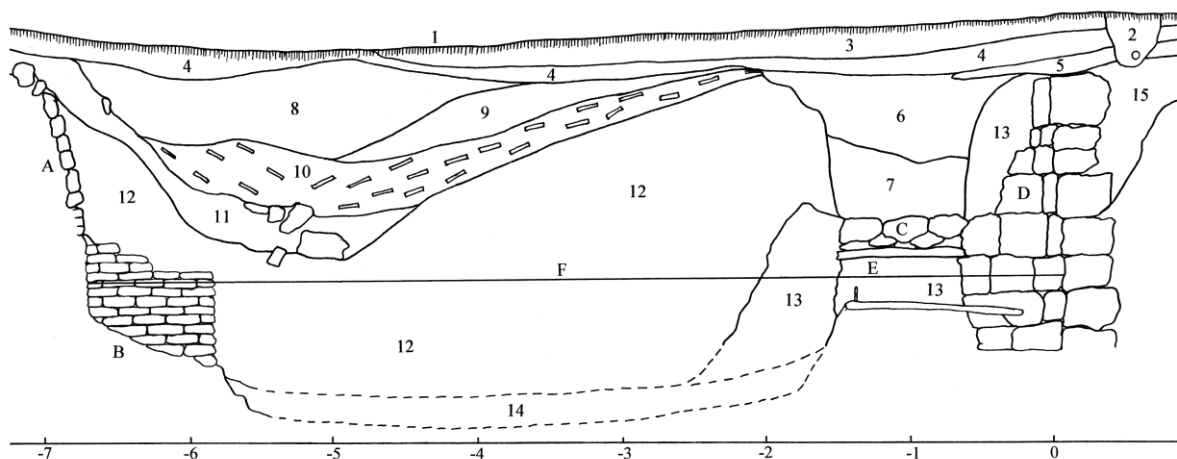
Fig 10 Guildford Park Manor. Simplified section, looking north, of the western side of the moat, showing features and levels revealed in A, B and B*, approximately 32m north of the origin at the south-west corner of the island. The letters indicate: A. Revetment wall, B. Brick pier, C. Foundations of manor house wall, D. Garderobe pit, E. Garderobe pit drain, F. Water level. Descriptions of the numbered levels are as follows: 1. Turf, 2. Modern trench (taking a water pipe to the garden pond), 3. Light grey fill, 4. Black topsoil, 5. Black soil with fine tile fragments, flints and chalk (possibly floor around the garderobe), 6. Black topsoil with small tile fragments and flints (upper part of robber trench), 7. Mortar and soil mixed (lower part of robber trench), 8. Dark brown soil with small flints and tile fragments, 9. Chalk, flint and tile, 10. Tiles, 11. Clay, flints, chalk, bricks and stone, 12. Mortar, tiles bricks and chalk, 13. Dark soil (fill of garderobe pit), 14. Silt, 15. Clay and tiles (possibly construction trench for garderobe pit). The axis below the section is marked in metres west of the origin.

The excavation confirmed that the content of the moat was indeed mainly building rubble. An indication of the proportions of the different materials involved, measured in buckets, is roughly as follows: flint 50%, tile fragments 36%, brick fragments 6%, chalk 5%, stone 3%. There were also some fragments of window glass and, from below water level, pieces of timber, one of which was about 0.8m in length. This material was packed in a large quantity of loose mortar and some mortar was also attached to the flints, bricks, tiles and stone. The shape of some of the mortar on the bricks indicated that they had originally been bonded to flints and some of the bricks were still attached to small pieces of timber. Thus, not surprisingly, it appears that the manor house was a complex structure embodying, at the end of its life, a wide range of building materials. From the lie of the tiles (fig 10) it was clear that most of the rubble had been tipped into the moat from the island and a few sherds of pottery indicated that this had occurred during the early 17th century. However, some rubble had clearly been tipped from the western side of the moat. The fill also contained many animal bones including those of deer, cows, pigs, sheep or goats, horses, rabbits and poultry, a large number of oyster and mussel shells and, very appropriately, some antlers. The robbing of the inner moat wall post-dated the filling of the moat.

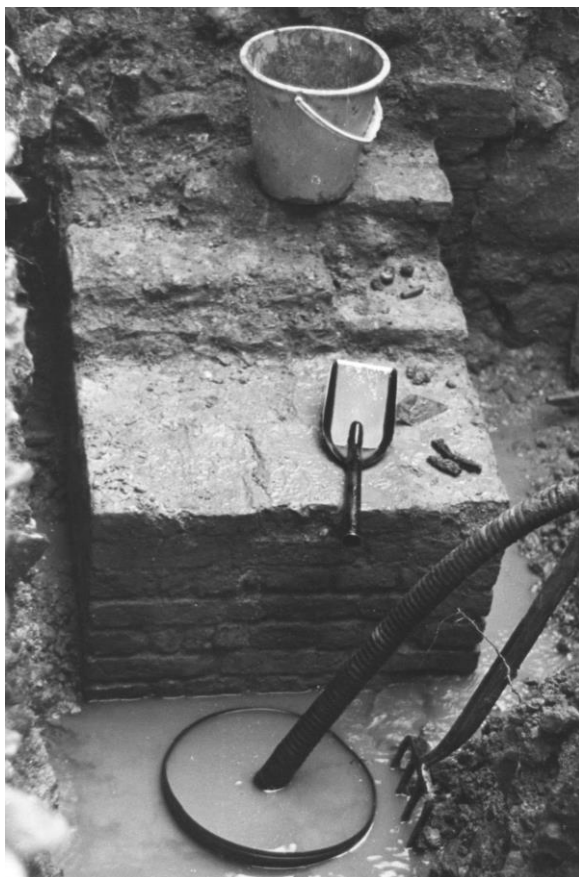
Fig 11 Guildford Park Manor. Photograph of the 'Tudor' brick abutment or pier projecting from the revetment wall at the west end of A and B*, taken while water was being pumped away.

At the western end of A, the top of a structure built of thin 'Tudor' bricks was discovered projecting from the outer revetment wall just above water level. This part of the trench was therefore widened to 2m on the north side and, by pumping out the water, which poured continuously through the wall from the wet part of the moat at the north end of the island, excavated to a depth of about 2.50m. The extension is labelled B* in figure 9. The abutment or pier proved to be 0.65m or ten courses of bricks deep, 0.73m wide and to project 0.95m from the revetment wall, which extended 1.70m above its top. The bonding was English and the structure clearly post-dated the wall (fig 10). It was originally higher and had presumably been robbed to the water level of the moat, which suggests that this level has not changed since the early 17th century. The bricks were typically 23 x 11 x 5cm and a rich red colour. In front of the abutment, the silt of the moat was reached at a depth of 2.40m and a test with an auger indicated that the silt was about 0.35m thick. A photograph of the abutment taken when the water in the trench was being pumped away is shown in figure 11.

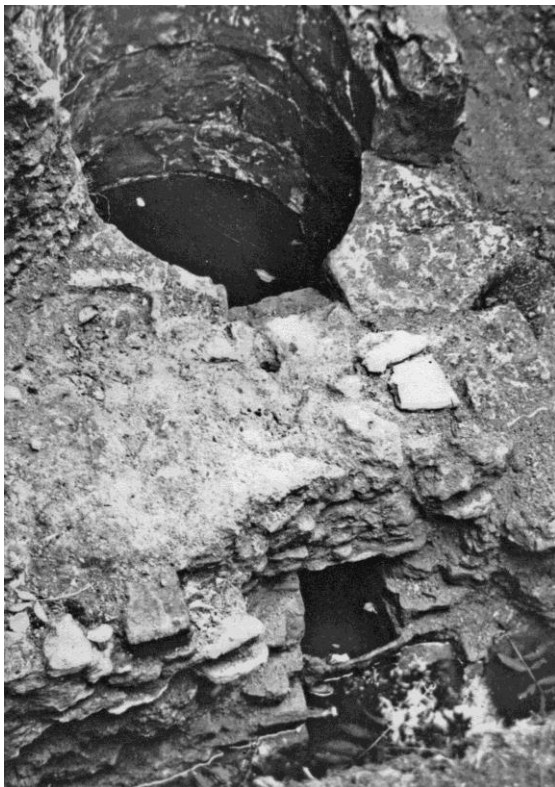
Fig 12 Guildford Park Manor. Photograph looking downwards from the west into garderobe pit 1, excavated at the edge of the island in A and B. Note the circular pit constructed of chalk blocks at the top, the robbed manor house wall across the centre and the outlet of the drain, together with the top of the iron plate at its outer end, at the bottom of the photograph. The water of the moat is present in the foreground and inside the pit.

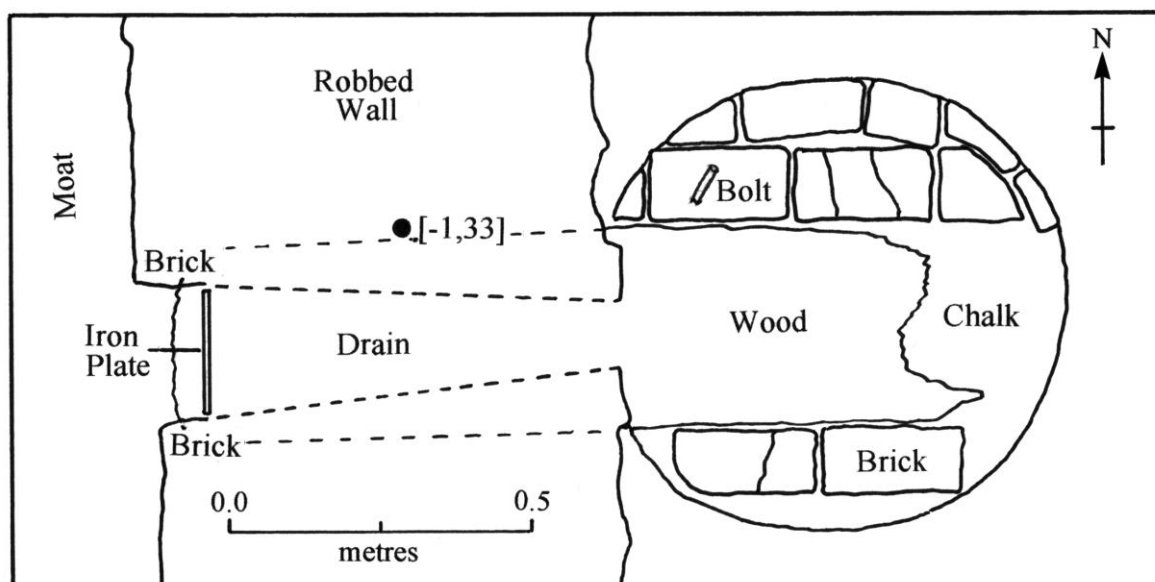
Fig 13 Guildford Park Manor. Plan of the base of garderobe pit 1 and its drain in A and B. The point with co-ordinates [-1, 33] relative to the site origin is marked.

end. Its walls were of thin bricks standing on the edges of the plank and it was capped with stone. Near the outer end, 70cm from the garderobe, the drain was partially closed by an iron plate. A plan of the base and the drain is shown in figure 13, and an elevation of the outlet of the drain in figure 14. The garderobe itself was constructed of seven courses of chalk blocks beautifully finished on the inner faces to provide a smooth surface. Slightly over one-half of the perimeter of the top of the pit, which was 30cm below the turf, had been destroyed by the robber trench associated with the moat wall. The lower half of the pit was complete.

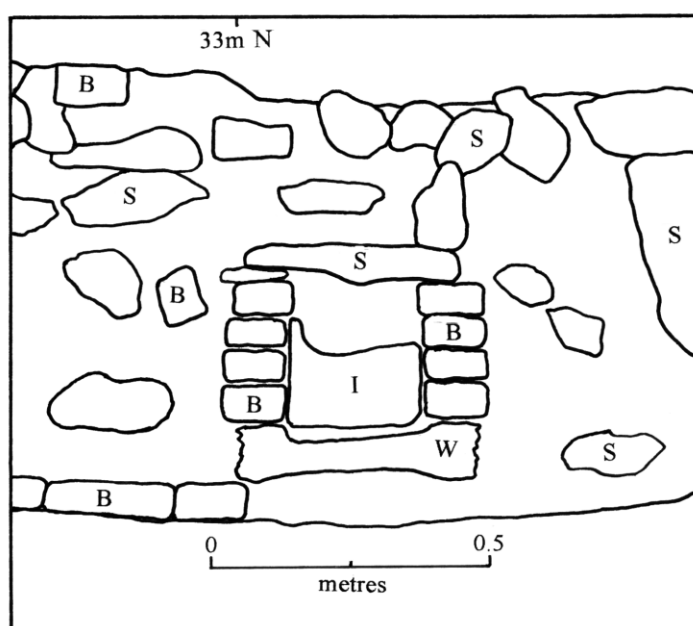
Fig 14 Guildford Park Manor. Elevation of the outlet of the drain of garderobe pit 1 in B. The section is on average 1.4m west of the origin at the south-west corner of the island; 33m north of the origin is marked at the top of the figure. The letters B, I, S and W indicate Brick, Iron, Stone and Wood respectively. The rest of the foundations of the wall were stone covered with mortar.

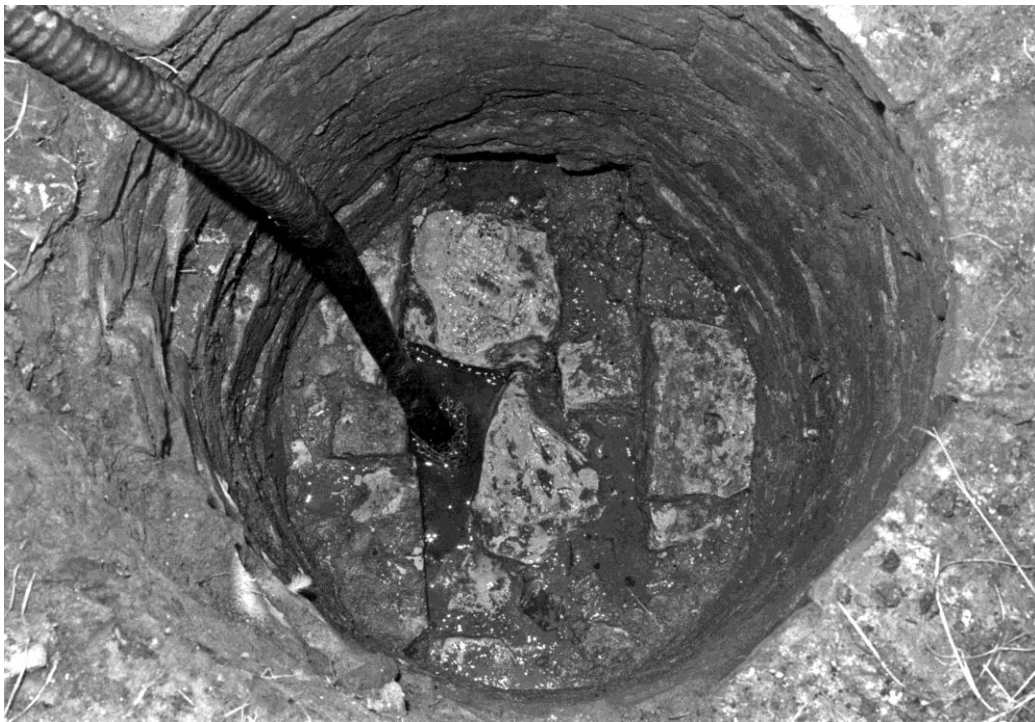
Fig 16 Guildford Park Manor. Photograph, from the west, looking downwards into garderobe pit 3 in I. This was taken while water was being pumped away and reveals the base of the pit and, towards the top of the photograph, the entrance to the drain into the moat.

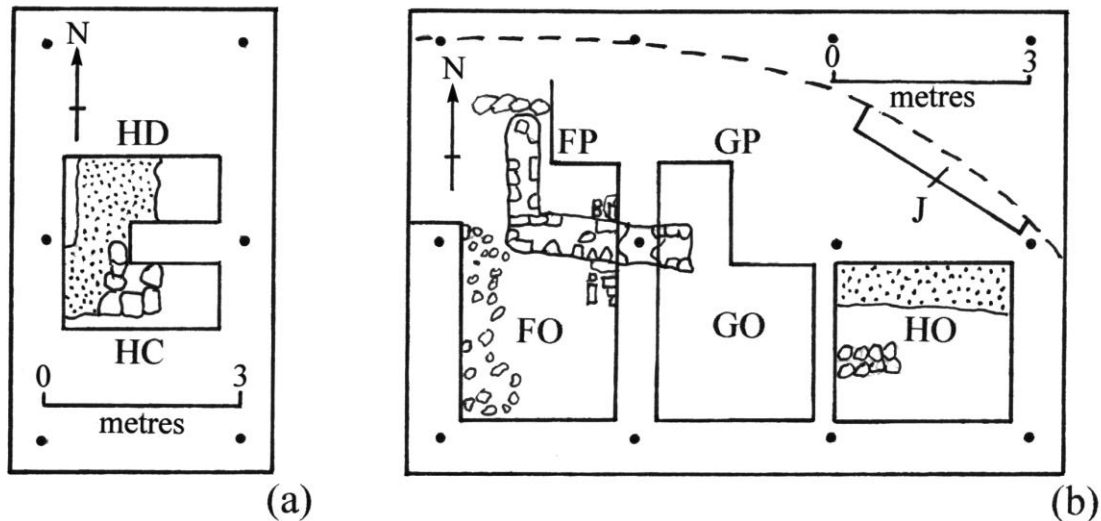
Fig 17 Guildford Park Manor. Outline plan of the excavations at (a) the south-east corner of the island and (b) the north-east corner of the island. In (a) the partially robbed foundations of the south-east corner of the manor house are revealed. In (b) substantial wall foundations in FO and GO continue as a robber trench in HO. A drain of 'Tudor' bricks passes underneath this wall in FO-FP and the remains of an early medieval wall are shown in HO.

These observations suggest that a corner of the manor house could be in HC and therefore parts of HC, HD and HC-HD were excavated, as shown in figure 17a. The partially robbed foundations of the corner of a substantial wall, about 1.0m wide, were indeed found at a depth of about 50cm. These are illustrated in the photograph of figure 18. About 40 fragments of mixed pottery were found including unglazed gritty, sandy and shell-tempered wares, green-glazed cooking vessels and cups, heavy transparent lead-glazed ware and Victorian willow pattern china. More significant perhaps were more than 50 fragments of decorated Penn floor tiles, a small piece of a blue-on-white, tin-glazed, maiolica floor tile, 143 pieces of window glass, some of which were decorated, and several lengths of came (lead glazing bar). There were also 37 nails, seven iron hooks, an iron ring 2.3cm in diameter, a horse-shoe-shaped heel plate, a slightly curved brass pin, a button, a bone from a goat or sheep and a small horn. Unfortunately, the robber trenches had left the ground severely disturbed and most of these finds were not stratified. It appears, however, that this part of the site had been occupied from the late 12th century and that it had housed a royal chamber with glazed windows.

The excavation of J, north of HO in figure 17b, was intended to investigate the structure of the moat wall at the north-east corner of the island. The wall was very decayed but it was concluded that it was essentially a chalk core faced with flint. The finds included pottery, much of it modern, glass, roof and floor tiles, bricks and stone. Two of the tiles were complete but very worn mid-14th century Penn tiles. One of these had the legend SIGNUM SCE CRUCIS, again suggesting they came from the 1369 chapel.

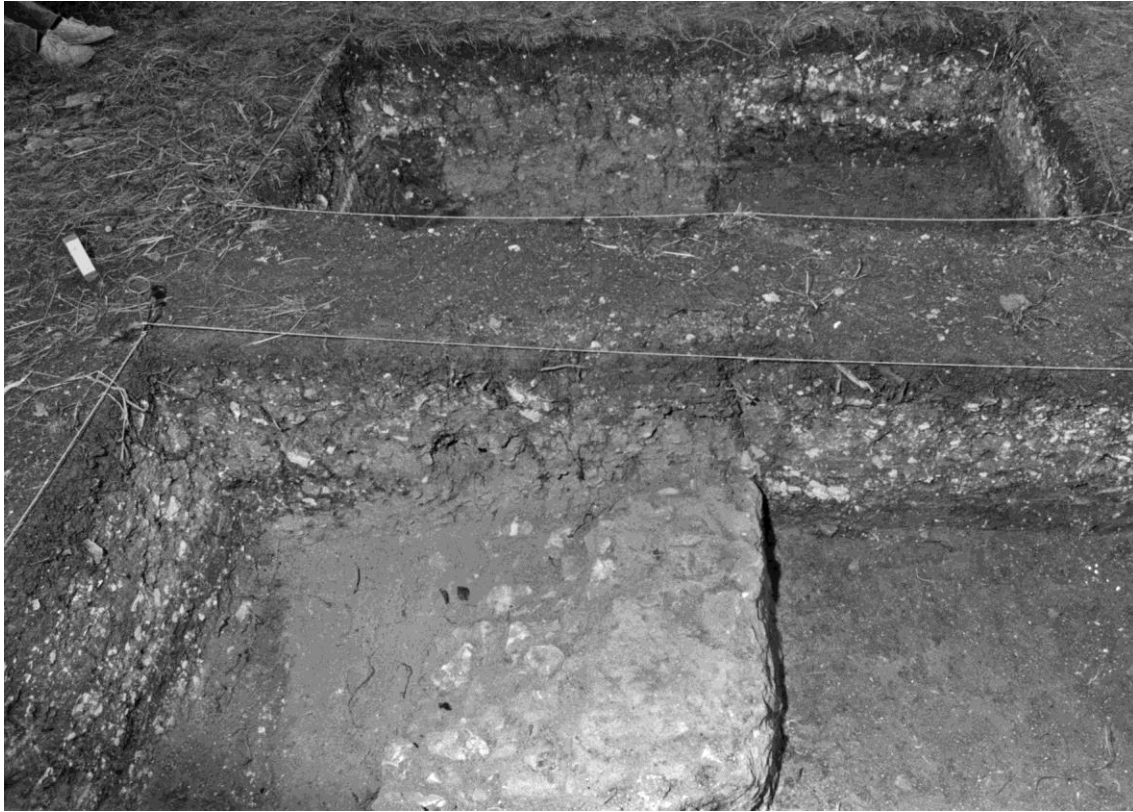
Fig 18 Guildford Park Manor. Photograph, looking north, of the foundations of the south-east corner of the manor house in HC, in the foreground, and a section of the corresponding robber trench in HD, in the background.

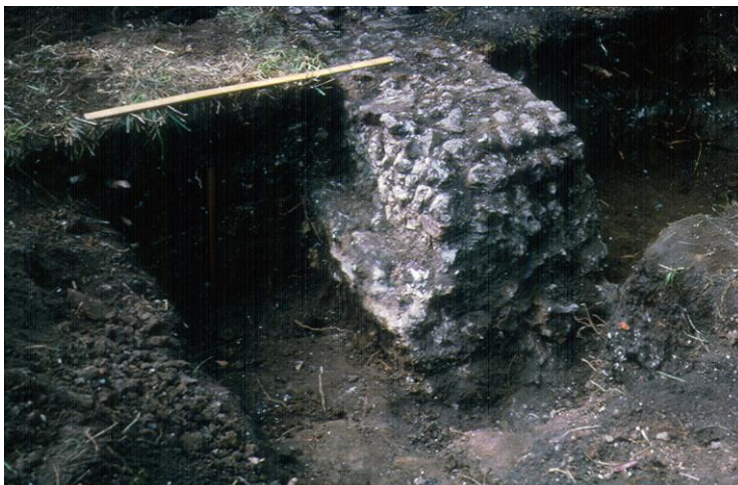
Fig 19 Guildford Park Manor. Photograph of the west parts of GO and GP and GO–GP showing the flint wall on chalk foundations.

Three squares, FO, GO and HO, parts of FP and GP, FO–FP and GO–GP and J were also excavated near the north-east corner of the island. The area investigated amounted to about 22.5m² and is shown in figure 17b. In the north-west corner of GO and along much of the north section of FO part of a substantial east–west wall was revealed about 10cm beneath the surface. The excavation was therefore extended northwards into FP and GP and the wall was found to be about 3m long and 60cm wide. It was constructed from flint with some thin bricks, was about 40cm high and stood on a foundation of chalk blocks, about 25cm deep and 70cm wide. A photograph of this wall is shown in figure 19. A complete, as new, mid-14th

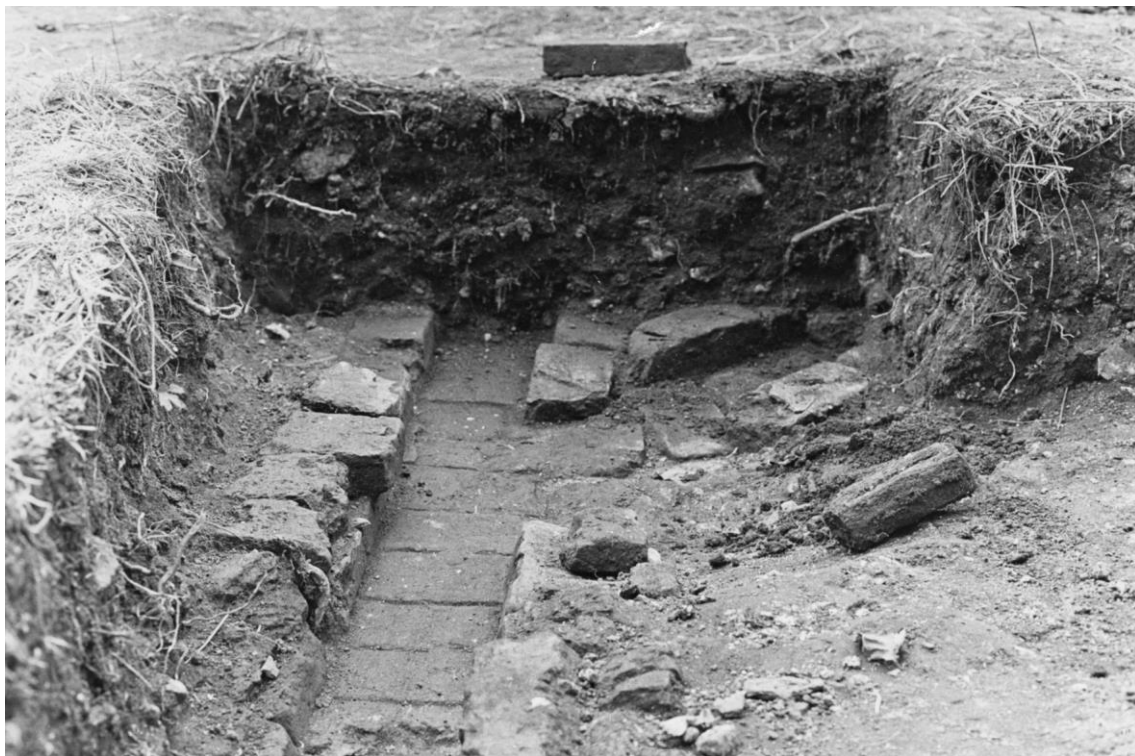
Fig 21 Guildford Park Manor. Photograph, looking south, of the junction between two brick drains which meet in EO.

In CN, DN, EN, EO, EP and FP and EM–EN, EN–EO and EP–FP were found approximately 18m of interconnecting open drains, about 50cm below the surface. These were constructed from thin ‘Tudor’ bricks laid across or along the bottom and, in two courses, lengthwise along the sides. The channels were of rectangular cross-section from 5 to 10cm deep and from 14 to 20cm in width. Pottery found above and below these drains suggests that they were laid in the early 16th century. A photograph including one of the junctions is shown in figure 21. The drains discharged through a single channel into the moat at the north end of the island, 16m from the north-west corner. They commence about 9m south of this, near the robber trench in EM.

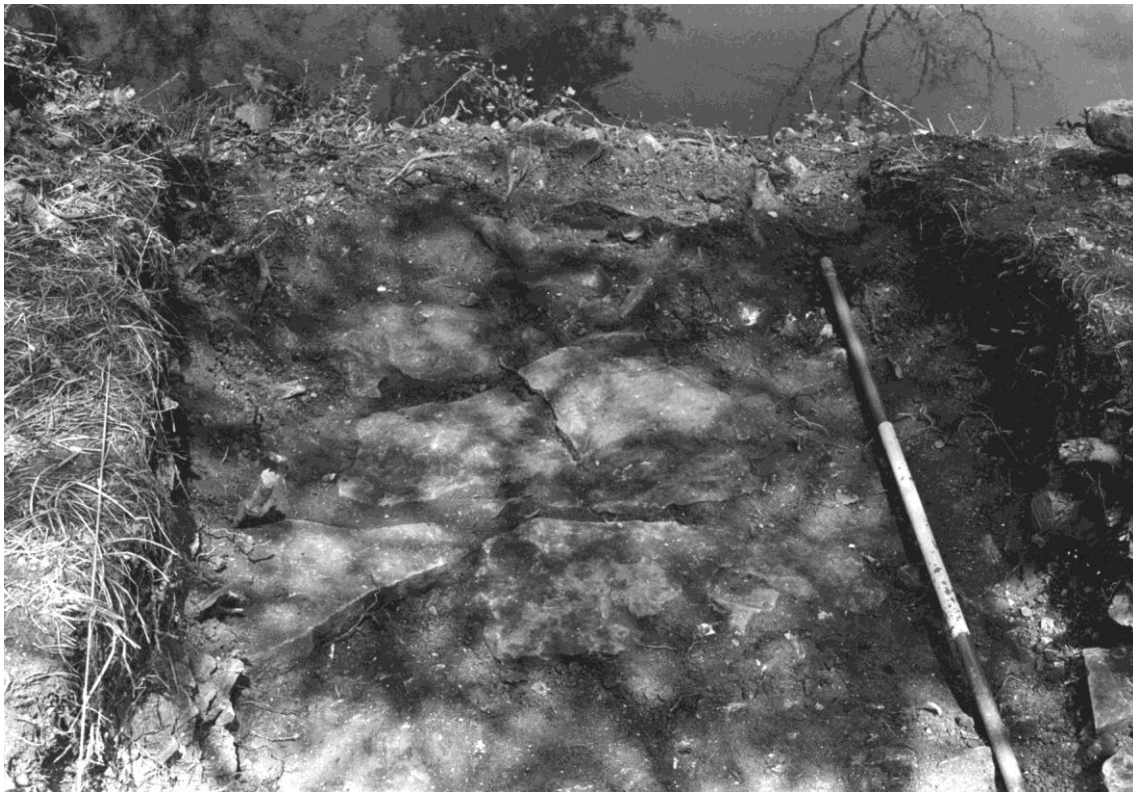
Fig 22 Guildford Park Manor. Photograph of the section of Horsham Stone pavement in EP at the northern edge of the island. Reflections of trees on the opposite side of the moat can be seen in the water at the top of the photograph.

An area paved with twelve slabs of Horsham stone was discovered at a depth of 50cm in the western half of EP, covering an area of 2.4m². Several similar slabs, but rather disturbed by tree roots, were also found 9m farther west in BP. This suggested that there was a paved path along the moat edge. However, there was no evidence of this in the east of CP. A photograph of the stones in EP is shown in figure 22. Underneath these slabs was found the remains of a clay embankment about 30cm high, presumably cast up from the moat. Beneath this was the original topsoil and undisturbed clay. Two groats of the second reign of Edward IV, dating from about 1473, were found in the topsoil about 1.5m apart, one in CP and the other in CO. Also in CO was found part of another badly worn mid-14th century Penn tile with the inscription SIGNUM SC'E CRUCIS.

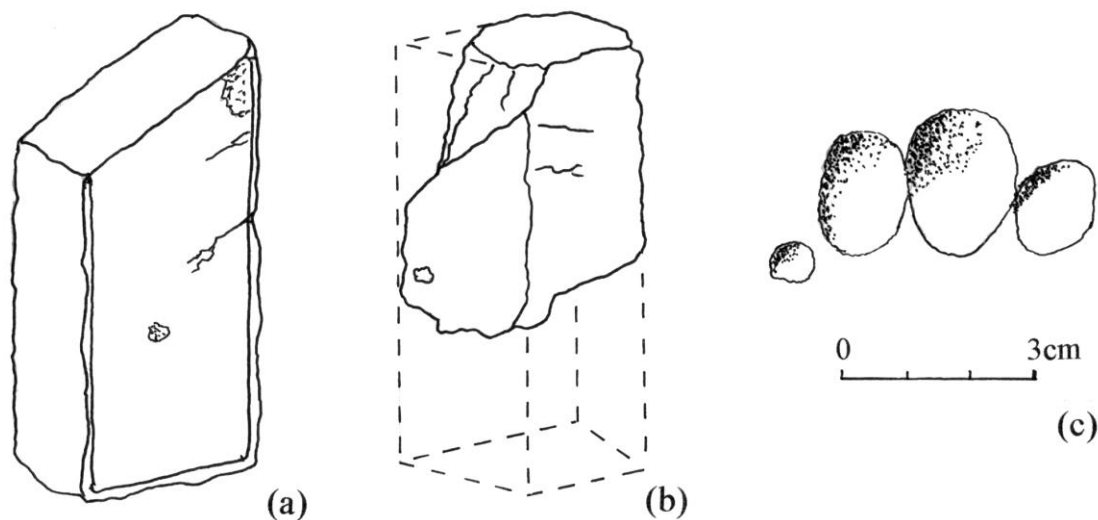
Fig 32 Guildford Park Manor. Shaped bricks excavated from the rubble fill of the moat in A. That shown in (a) is of a deep red fabric and measures 233 x 110 x 55mm. The top face is at an angle of 60° to the right-hand side face. A slight depression along the three orthogonal edges of the front face is indicated. The fragmentary brick (b) has an orange-red fabric and measures 105mm across the back, 73mm across the front and is 55mm thick. The left-hand face is at angle of 55° to the back face. A print of a left paw or small hand on the back face of brick (b), based on a rubbing, is shown in (c).

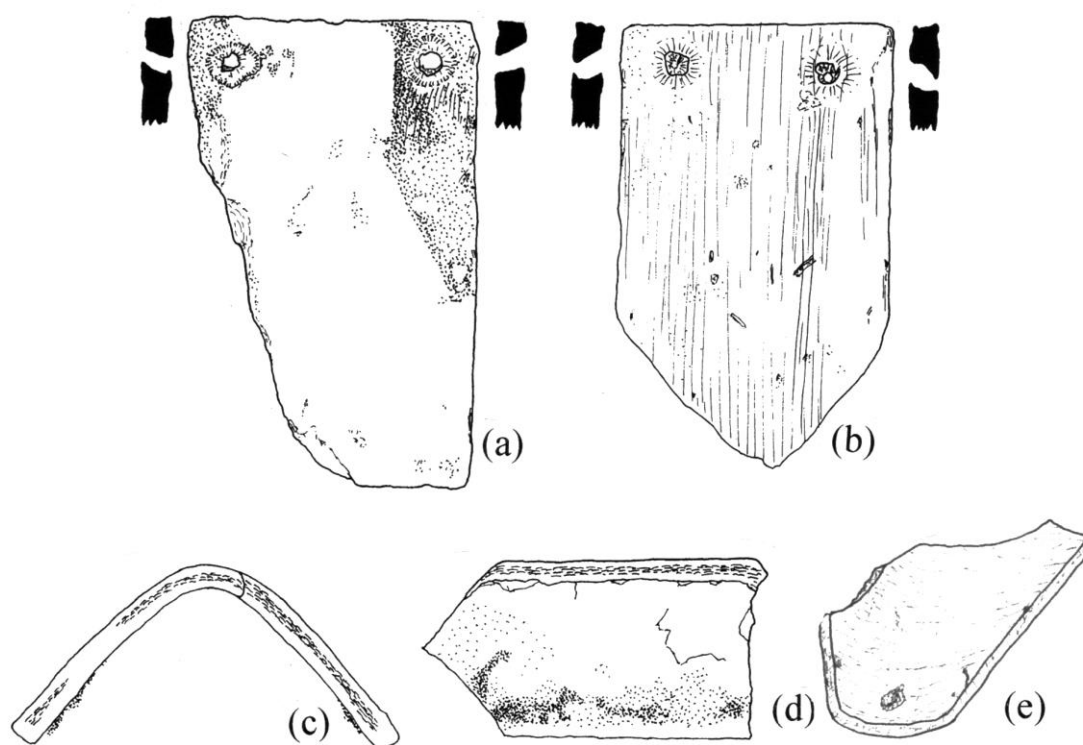
Fig 34 Guildford Park Manor. Drawings of roof tiles. (a) Back, slightly convex, face of a plain tile, 165mm across, 272mm long and 16mm thick, from the fill of the moat. The speckled shading indicates the presence of mortar, roughly proportional to its density. (b) Front, slightly concave, face of a shaped plain tile, 159mm across, 261mm long and 16mm thick, from the fill of garderobe pit 1 in B. The holes in (a) and (b) slope downwards a little from the front to the back faces, as indicated by the cross-sections. (c) Composite elevation of the two ends of a ridge tile, 230mm across, 108mm high and 16mm thick, from AK. (d) Elevation of the inner surface of this ridge tile. The linear shading in (c) and (d) represents reduced black fabric. (e) Upper part of a valley tile found in DN.
