## **Report on the results from a resistivity survey and test trenching in advance of a new footpath between the postern gate and the bailey buildings at Farnham Castle, Surrey**

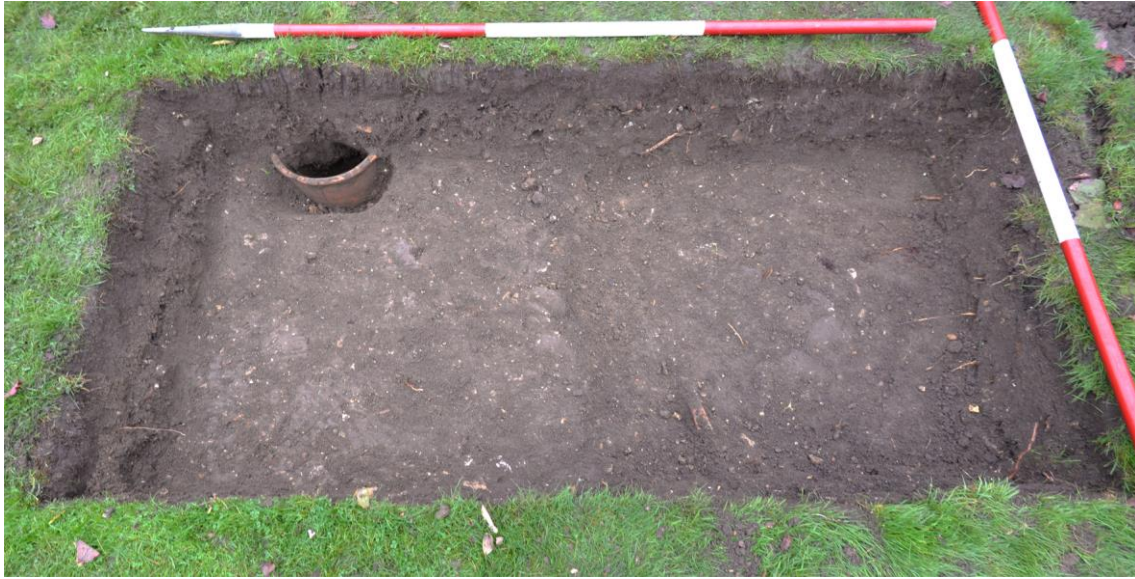
The only find of interest was in the north-east corner of trench 1 where a large earthenware pot (22cm diameter at rim; fig 3) had been set into the ground with its rim more or less at the top of the gravelly layer and its base, presumably, reaching the underlying grey soil. The pot was filled with what appeared to be topsoil and may have contained a plant of some sort. It was left *in situ*.

Fig 3 Trench 1 looking east showing pot set into gravel/brick deposit.

In trench 1 a small sondage was opened to a total depth of 30cm and showed that the finer stone layer, in turn, overlay a 9cm-thick layer of larger stones mixed with larger pieces of brick, tile and lumps of clunch. The base of this layer lay on a deposit of lighter grey soil, but no attempt was made to investigate any deeper because of the depth restrictions imposed by the WSI. There was no sign of any edge to the deposits within either trench.

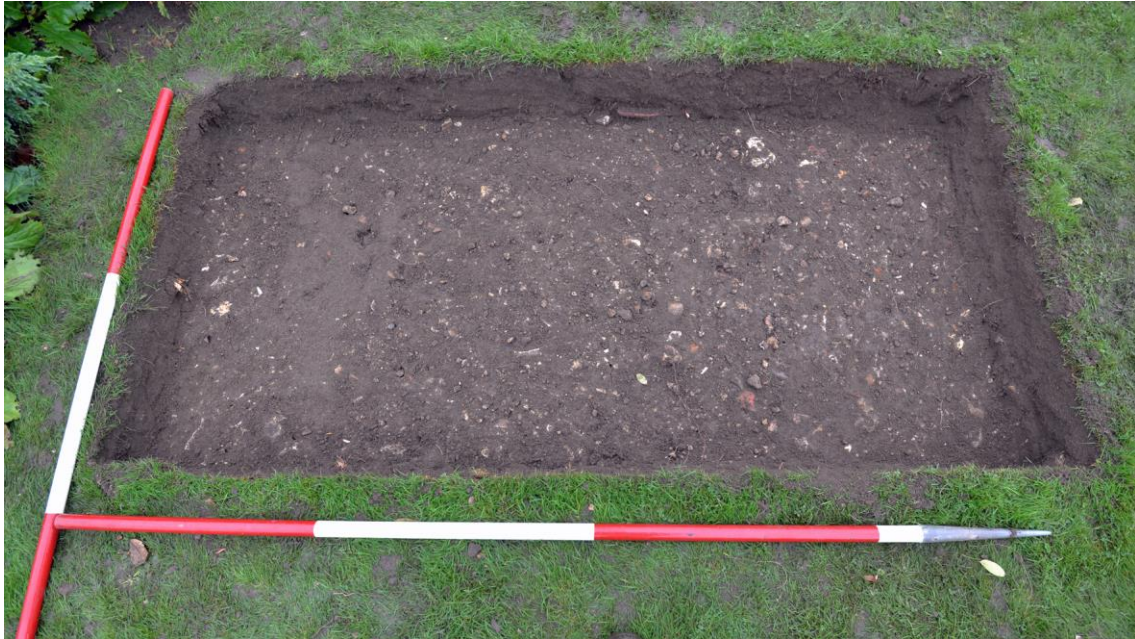
Fig 4 Trench 2 looking east showing surface of gravel.
