Report on a Watching Brief at Pennys, 88B West Street, Farnham, Surrey GU9 7EN

Background: The site of building works (WA/2016/2024; SU 8363 4680) to construct extensions on the south-west and north-east corners of the existing building, which lies to the rear of the garden of Bethune House. At the request of Mr N Truckle, Archaeological Officer, Surrey County Council, the footing trenches for the above works were inspected on 27 January 2017. Prior to the visit, the trenches had been excavated and the topsoil removed from the site.

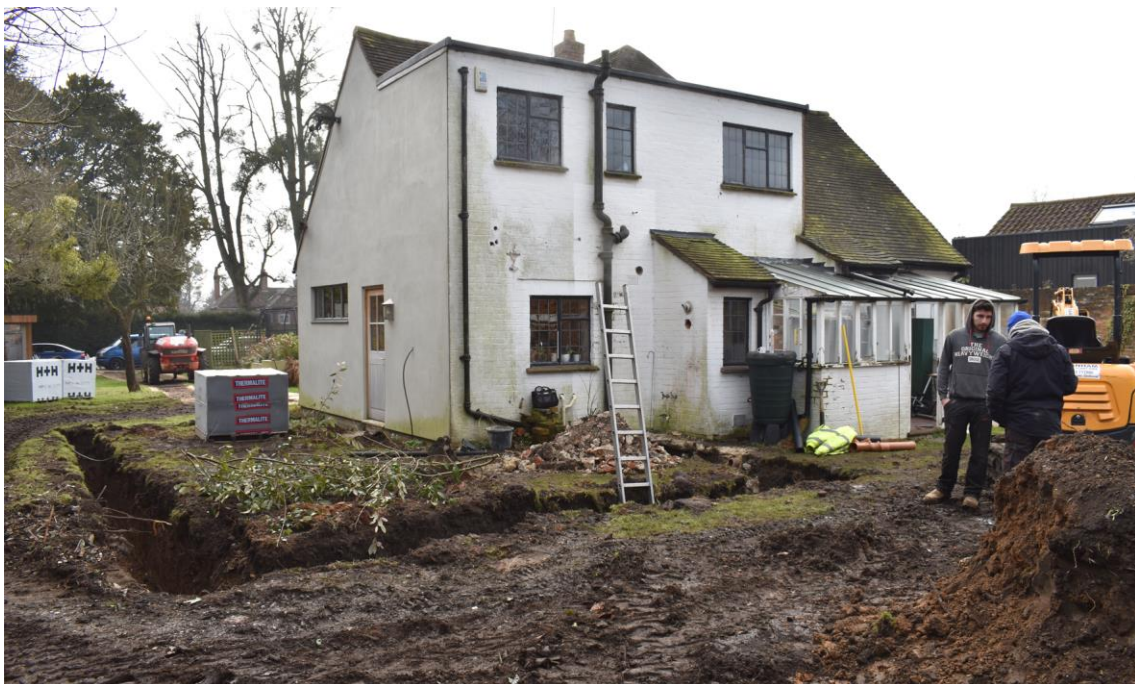
Pennys, 88B West Street, showing the north-east extension footing trench.

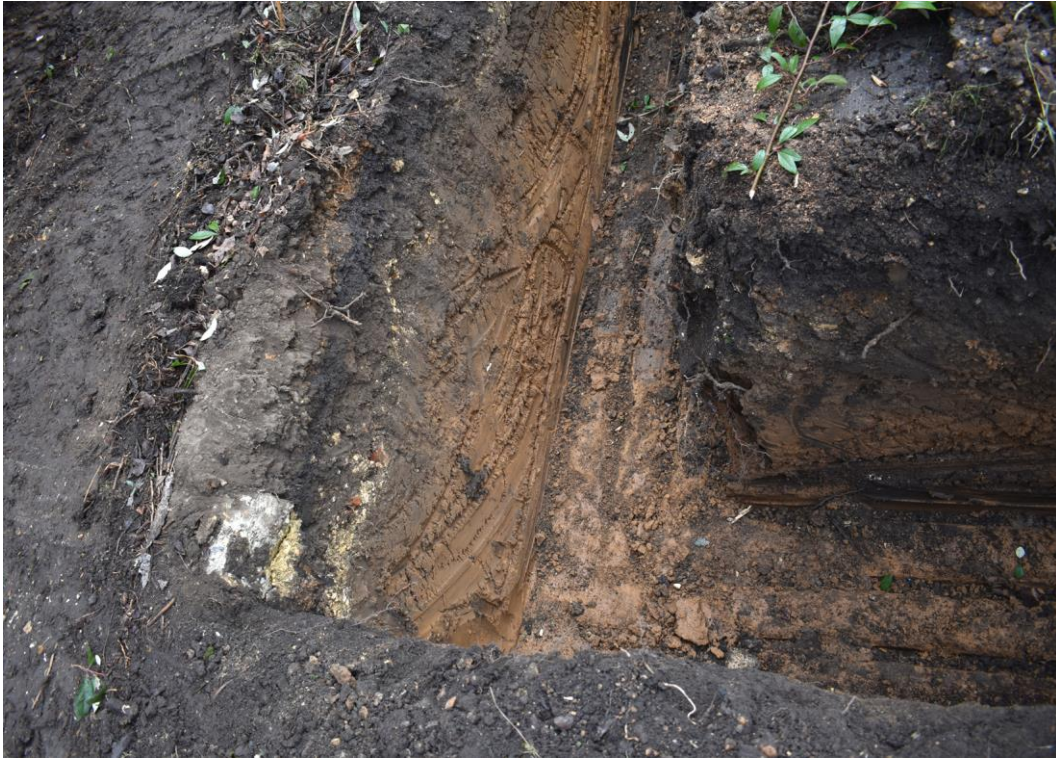
The footing trenches: The footing trenches for the larger of the two extensions lay on the north-east side of the existing building and formed three sides of an approximate rectangle. The trenches were cut to a depth of 1.1m below the ground surface and the section consisted of upper layers of garden topsoil to a depth of about 60cm on average. Showing in parts of the section were the remains of a relatively recent garden path consisting of a layer of hardcore overlain by a band of gravel. No other features were observed and no finds were recovered other than pieces of modern roof tile. Below the garden soil level the trenches were cut into Gault clay to an overall depth of 1.1m. The smaller south-western extension showed similar stratigraphy.

View of the section in the north-east footing trench showing Gault clay overlain by garden soils and the corner of a gravel path. The footing trench was difficult to access – hence the lack of a scale and oblique angle of view.

No further work is recommended.
