A NINETEENTH CENTURY SHEEP WASH AT FRENSHAM GREAT POND

(SU 8409 4006)

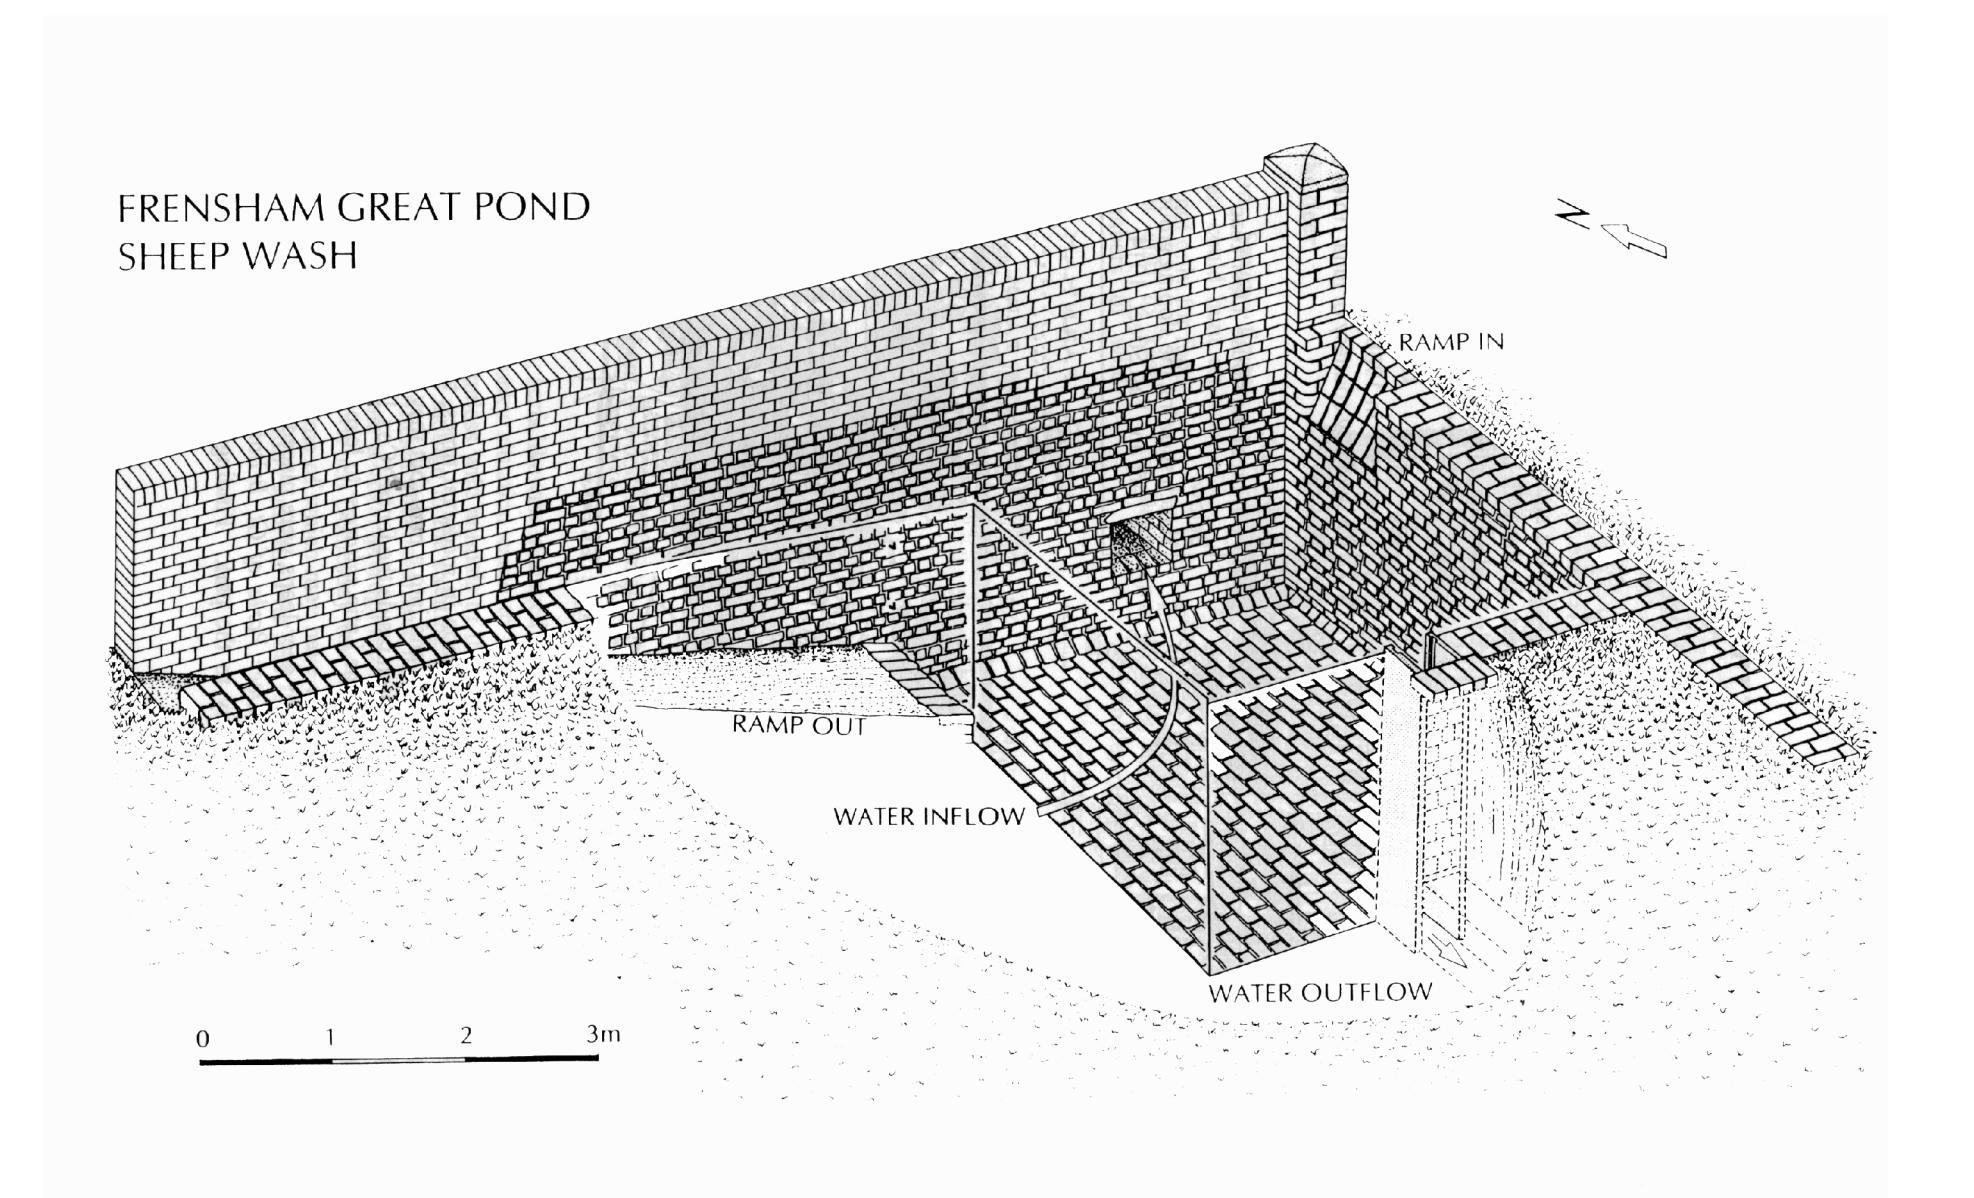
The wash itself is set into the centre of the dam and consists of a brick-built structure some 3.15m square and similarly deep. It has a brick floor and a short chute to the south where the sheep were forced into the water. To the north an inclined ramp leads out of the wash and presumably into further holding pens. Iron hinges remain in place at the deep end of the ramp, acting as hangers for a gate to control the exit of sheep. The water enters the structure through brick lined opening in the east wall and flows out through a long brick built square drain, dug into the back end of the dam to the west. There is no apparent way of blocking the flow of water into the wash, but the outflow passes through a stone lined slotted recess and can be dammed by the insertion of wooden boards to raise the water level to the required height. At some stage in the recent past a modern brick parapet has been constructed on top of the western wall of the wash to act as a safety barrier along the side of the road.

Sections of the walls are currently in a state of partial collapse because of pressure from tree roots and Waverley Borough Council's engineering department is considering how to deal with the problem. While most people walk past without even noticing the wash, and no one could claim it as an exciting monument, it nonetheless in its quiet way evokes an era that has now gone forever.
