Archaeological Evaluation at 45 Castle Street, Farnham

INTRODUCTION: During the summer of 2011, the authors were invited to carry out an archaeological investigation of the garden to the rear of no 45 (Fig 1; SU 83894 47104) prior to the construction of an extension to the house and subsequently to monitor the footing trenches during building works.

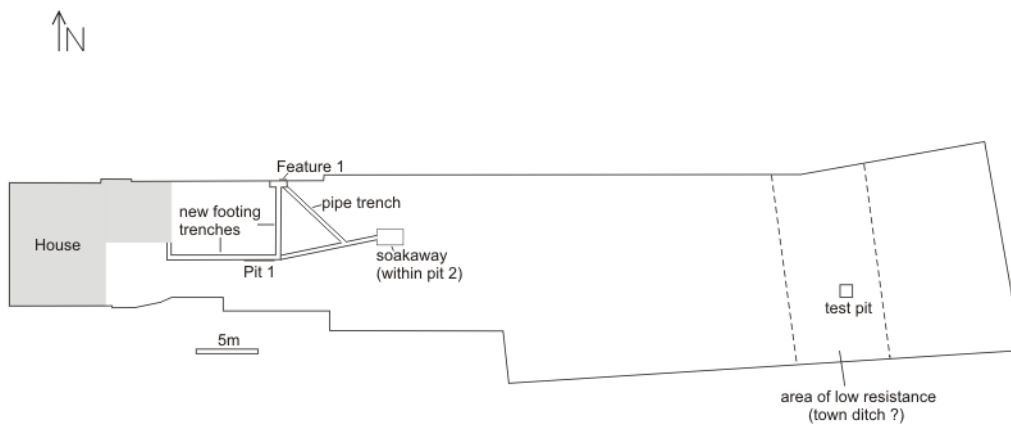
Fig 2 45 Castle Street: plan

THE EVALUATION: Prior to the commencement of building works a resistivity survey was carried out along the length of the garden. As already mentioned this showed a band of low resistance about 9m wide running across the garden (Fig 2). A small test pit was excavated in the centre of this feature which revealed a 70cm-thick band of topsoil sitting on a deposit of disturbed yellowish clay. This layer was tested to a depth of 1.9m below the modern ground surface and found to contain a scattering of ash, small fragments of coarse tile and the very occasional fist-sized lump of clunch. While the natural clay underlies the whole site, it had obviously been disturbed at this point to an unknown depth. Whether this represented the backfilled bank of the medieval town ditch is uncertain. The dimensions and position of the area of low resistance fit well with the projected line of the town ditch based on excavations further south between Castle Street and Bear Lane (Poulton 1998), as would the documentary evidence for the site being within the Borough. Only a deeper excavation would establish the truth of the matter. A subsequent resistivity survey was carried out in the garden of Guildford House immediately to the north, but unfortunately the lawn did not extend far enough eastwards to allow any northern extension of this feature to be detected.

SUMMARY: Little evidence was found for any domestic occupation of the site prior to the 18th century, but a resistivity survey showed a band of low resistance running north-south about two thirds of the way down the garden (Fig 2). This may be a continuation of the line of the medieval town ditch previously located just north of The Borough (Poulton 1998). Test pits and later examination of the contractor's footing trenches located two pits and provided evidence that the site had been extensively terraced.

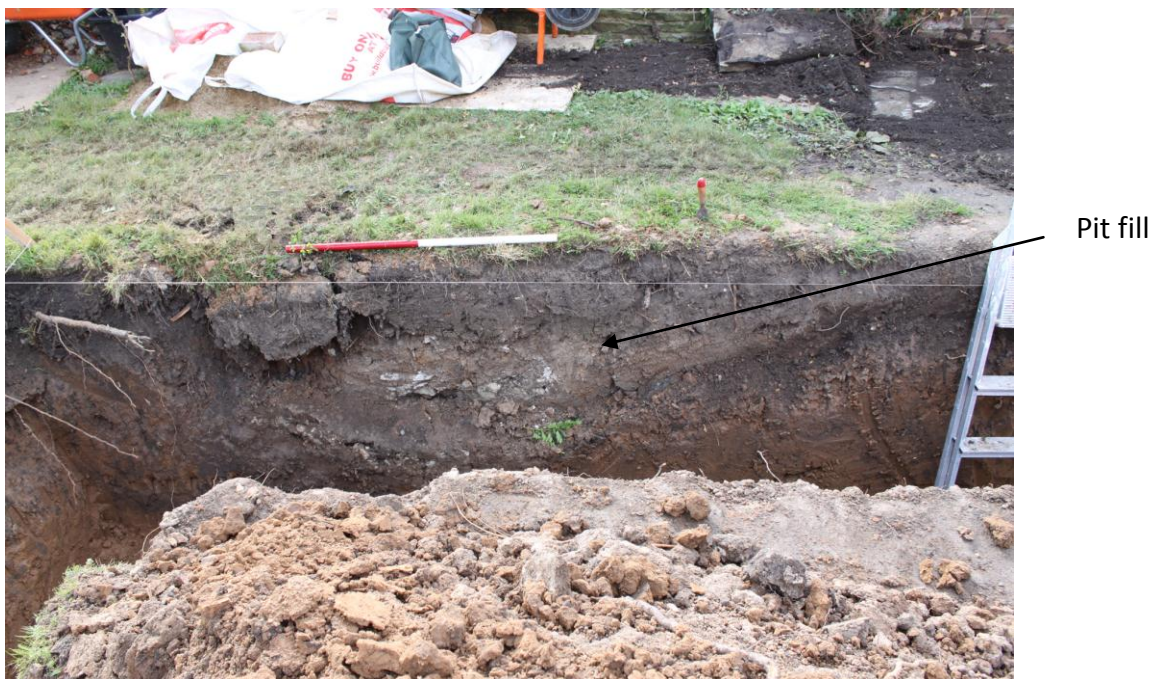
Fig 4 45 Castle Street: Pit 1

The footing trenches also cut through a concave pit (Fig 2, pit 1 and Fig 3) approximately 2.5m across the exposed face and 65cm deep. This had been cut into the natural clay and lay just beneath the topsoil which was, again, about 30cm thick. The pit contained two thin parallel curving bands of clunch rubble, a small amount of ash and a few oyster shells, but no datable material (Figs 2 and 4). Perhaps more interestingly the soakaway, some 8m to the east, appeared to have been cut into the fill of a much larger pit (Fig 2). While the extent of the pit is unknown it was tested to a depth of 1.9m where the underlying natural Gault clay was found. The pit contained a light scatter of brick, tile, bone and oyster shells but no pottery or other material. The tile and brick were entirely consistent with that visible in the existing house and probably date to some period within the 18th century. It would seem likely that the pit was used to dispose of domestic refuse and is certainly earlier than 1839, as the gravel path shown on the tithe map and found in the earlier test pit (see above) was also visible in the section running over the top of the pit fill.
