**Archaeological Watching Brief
Site of The Old Forge
Upper Church Lane
Farnham**

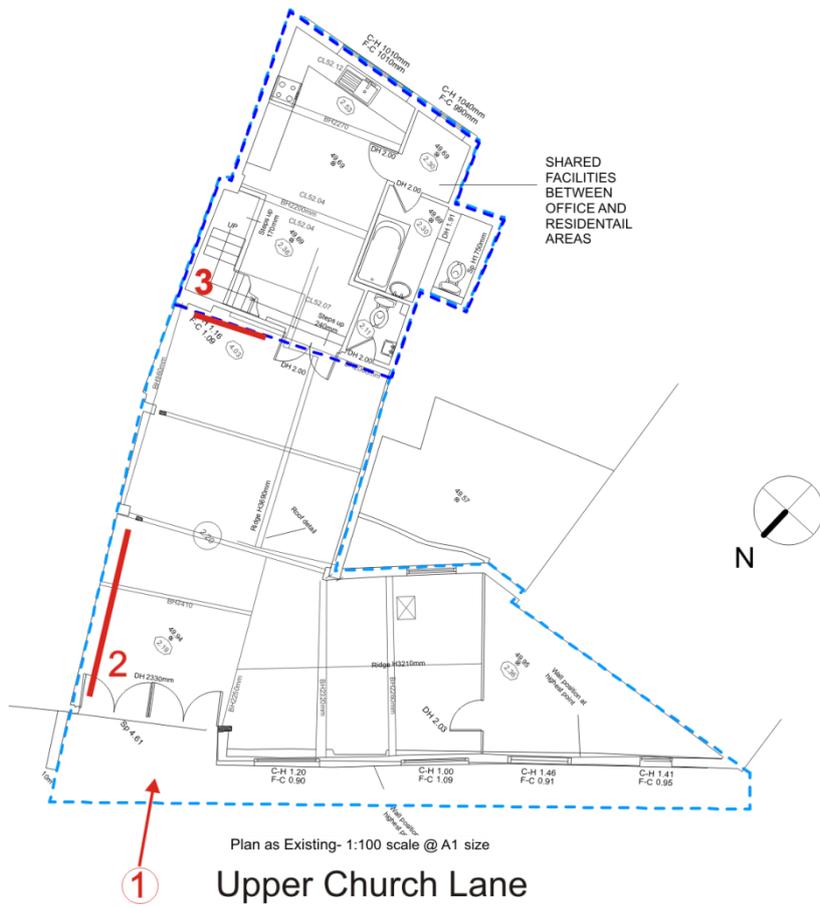
Site plan. Approximate position of new footing trenches and photograph numbers in red.

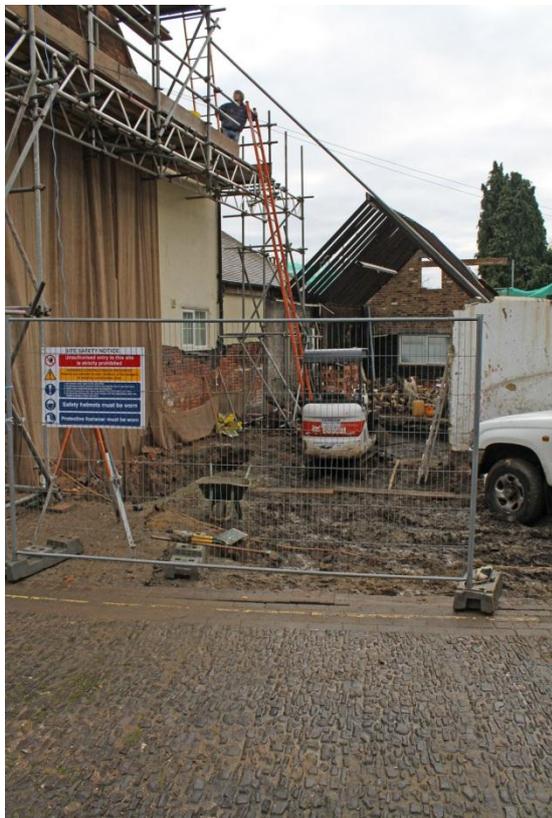
Photo 1

Unfortunately, the only deep cut trench on the site had been filled with concrete just prior to the visit despite the date and purpose of the visit being known to both the architect and contractor. It was therefore impossible to carry out anything approaching a proper inspection of the underlying stratigraphy.

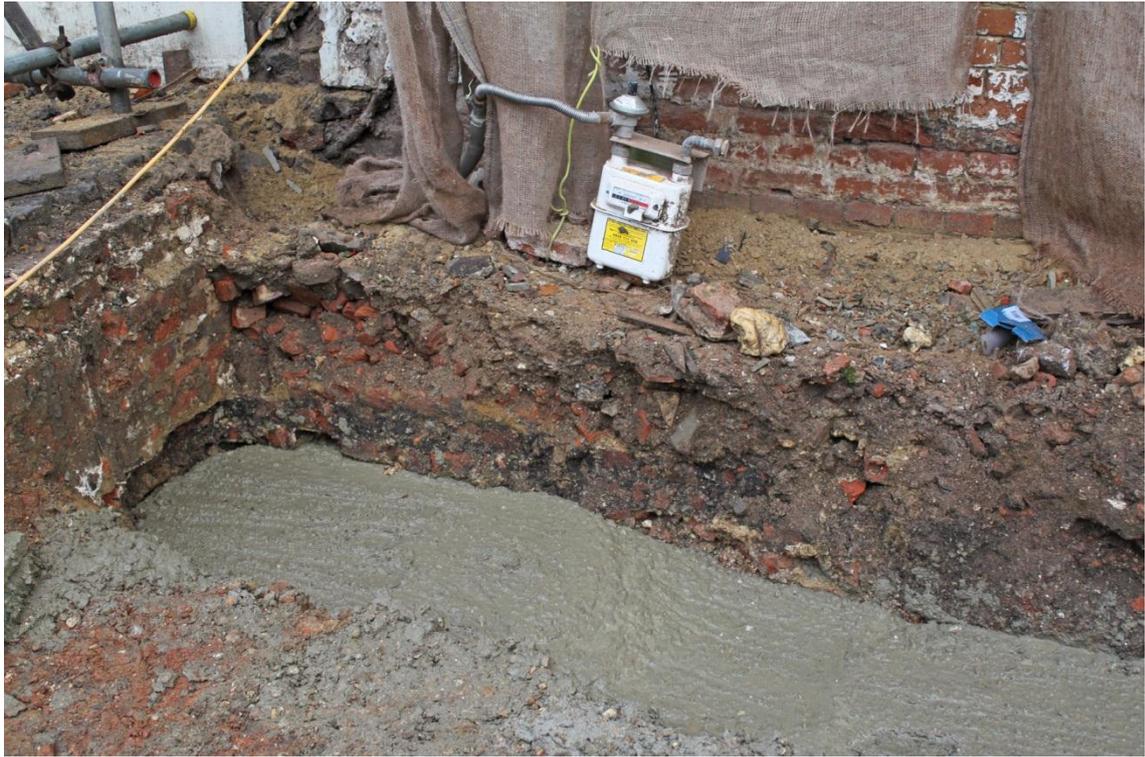
Photo 2.

The upper level of the concrete filled trench (no 2 on plan and photo) lay below the removed floor at the front section of the Old Forge buildings. The level was black with ash and contained 19th century pottery and the section showed evidence for a brick wall footing and associated brick floor. This obviously pre-dates the recently removed floor and probably relates to an earlier building on the site. This sequence of buildings would be entirely consistent with the pattern noted on a nearby site in Middle Church Lane (Graham FMS Newsletter Vol. 5, No 6, pp. 97-103 June 1979).

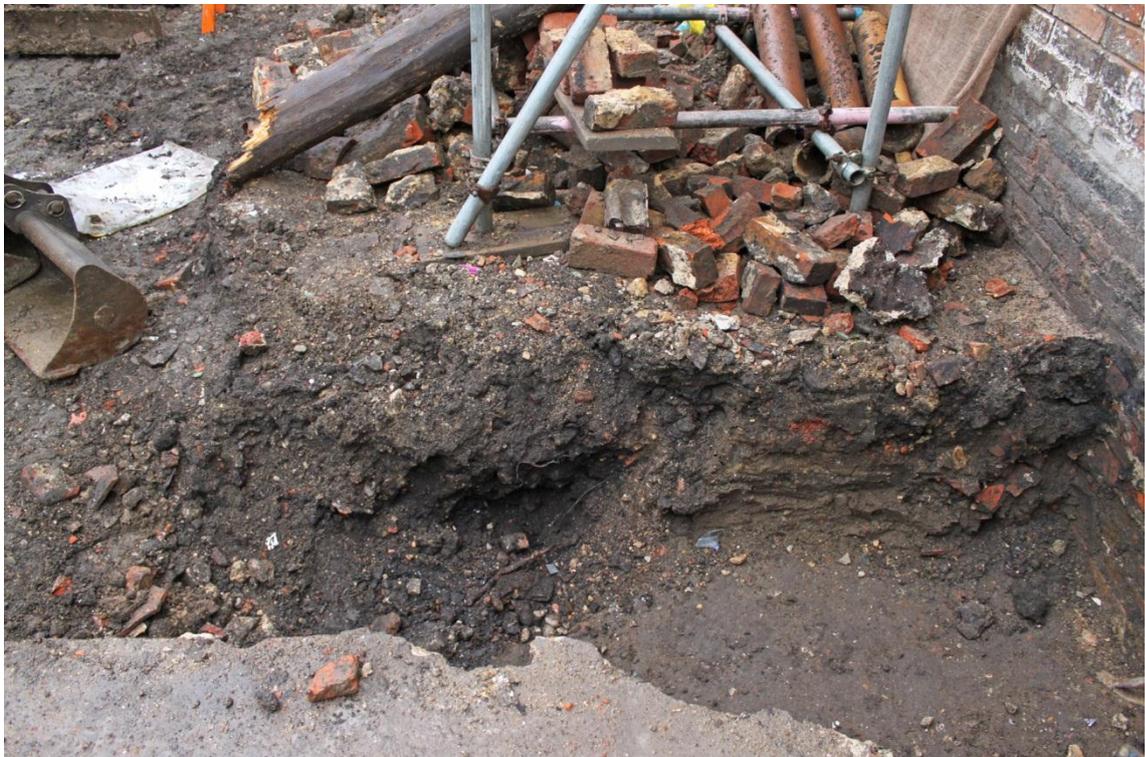
Photo 3.

A second trench (no3 on plan and photo) was about 35cm deep, though, not being filled with concrete, was open to inspection to its full depth. The photograph (3) shows, on the right, the footing trench associated with the eastern boundary wall, to the left of which is a section of brownish soil cut by a pit filled with ashy soil and late 18th/19th century pottery.
