Archaeological Watching Brief at 23 Castle Street, Farnham

Introduction: In December 2011 the author was invited to undertake a watching brief on building works in the garden to the rear of no 23 Castle Street (Fig 1; SU 83882 47031; site code CSF11). An initial visit to the site was made in late December 2011 and a follow up visit on 4 January 2012.

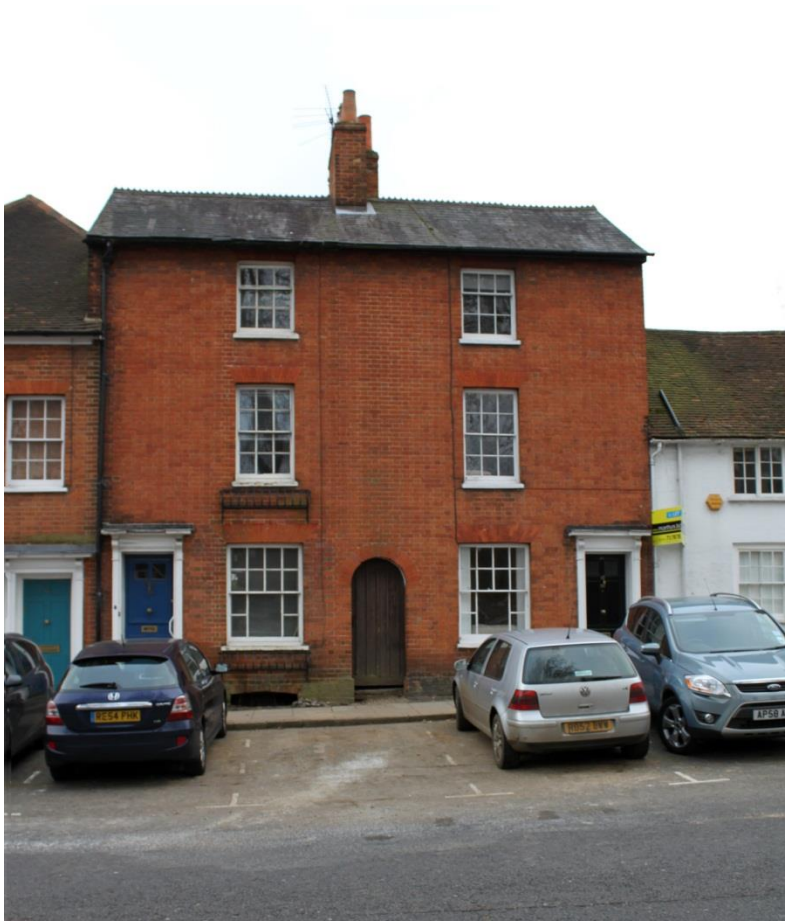
Fig 3 View of nos 23 and 24 Castle Street looking west. The door in the centre of the building gives access to the passageway leading to the rear of no 23.

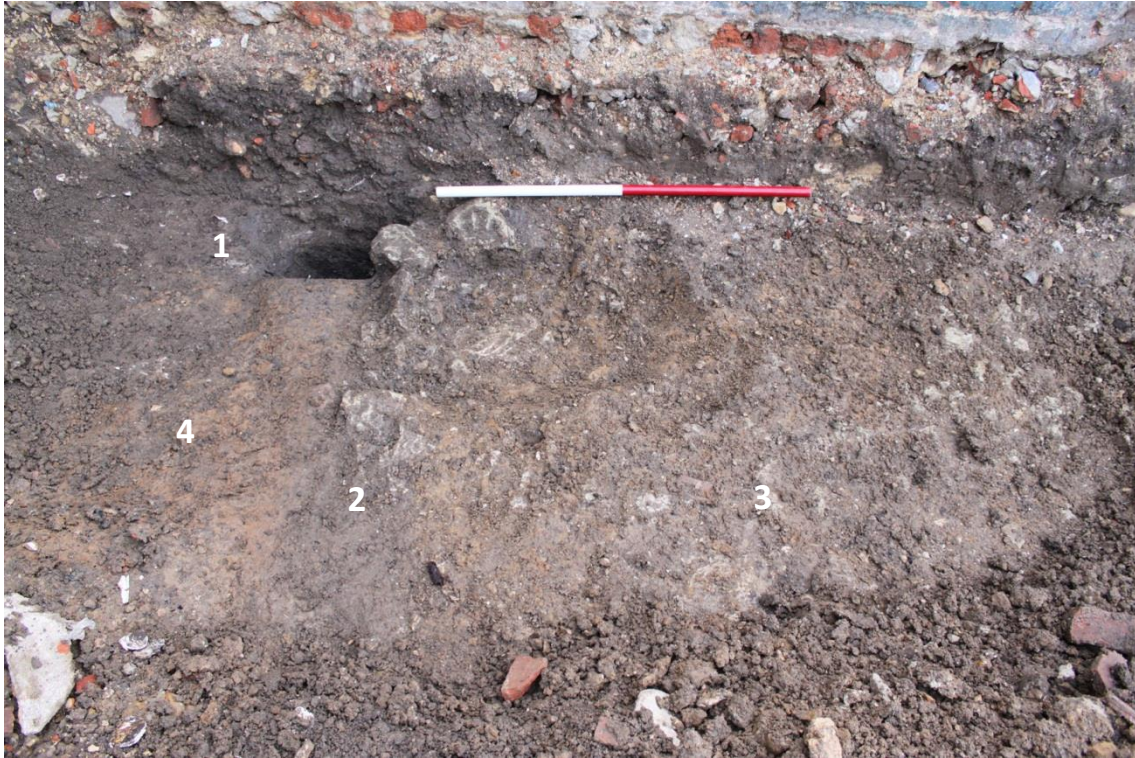
At a point 1.86m west of the rear of the house, the ditch had been cut by the clunch block footings of a wall which, at least in the exposed section of the ditch, were 90cm deep. This wall footing appeared to extend across the site more or less at right angles to the ditch and boundary wall and also to have extended westwards underneath the boundary wall for 2.75m before again turning across the site parallel to the first wall (Figs 2 and 4). While it was not possible to excavate under the boundary wall (for safety reasons) the southern clunch footing was tested in places and the western return was also just exposed running along the face of the western edge modern earthmoving works. The inside of the building had been filled with a 35cm-thick layer of gravel that again contained oyster shells, ash, bone and one sherd of a thin walled grey vessel similar to those found in the ditch.

It is therefore reasonably certain that the medieval ditch had been cut by a later building, probably late 15th or 16th century in date, that ran across the width of the plot, though whether it reached the north boundary is unknown as the modern building works had left a wide strip of topsoil intact along this side of the property.

In any event the building represented by these 22cm-wide footings must have been relatively small, probably consisting of a timber superstructure with a tiled roof. It seems likely that the ditch, which could be seen to continue in the garden to the west of the clunch footings, was infilled around this time. There was no evidence for the date of demolition of this small building, but the gravel inside it had an irregular layer of clunch on the surface that probably comes from this operation.

Fig 4 View of clunch wall footing and burgage plot ditch. (1) ditch and sondage; (2) wall footing; (3) gravel interior of building; (4) natural clay.
